## AVIATION INVESTIGATION REPORT

A00P0019

### CONTROLLED FLIGHT ONTO ICE

TGH HOLDINGS LIMITED (TERRY AIR)  
PIPER NAVAJO CHIEFTAIN C-GBFZ  
WILLISTON LAKE, BRITISH COLUMBIA  
7 FEBRUARY 2000

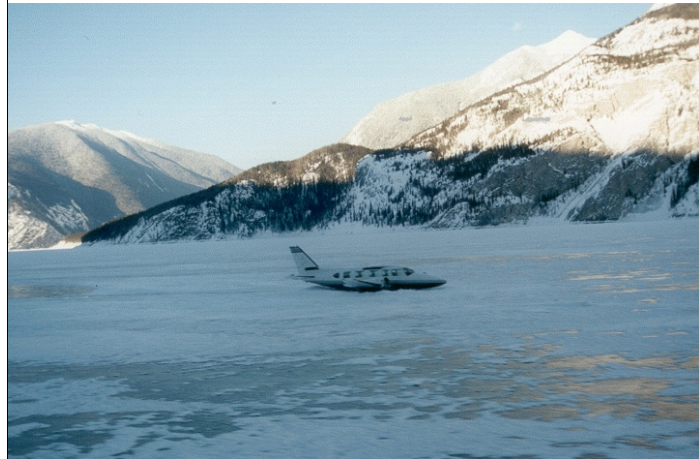
The aircraft was examined by TSB personnel at the crash site. To the extent examined, there was no indication of pre-existing deficiencies that would have caused the aircraft to lose altitude and contact the ice. The aircraft was reportedly operating normally up to the time of the crash. Impact markings reveal that the aircraft contacted the ice in a slight left bank and near-level pitch attitude on a heading of about 050 degrees magnetic (M). The first contact was the left propellor, followed by the fuselage and then the right propellor.

Photo 1  
Aircraft at crash site

1. Weather conditions at the time and location of the occurrence were not suitable for visual flight.
2. While the pilot was attempting to regain visual flight, he allowed the aircraft to descend and it struck the ice surface. The weather and surface conditions were such that it would have been virtually impossible to visually detect the ice surface.
